UNION LAKE DAM

PHASE I INSPECTION REPORT

NATIONAL DAM SAFETY PROGRAM

NJ 00448

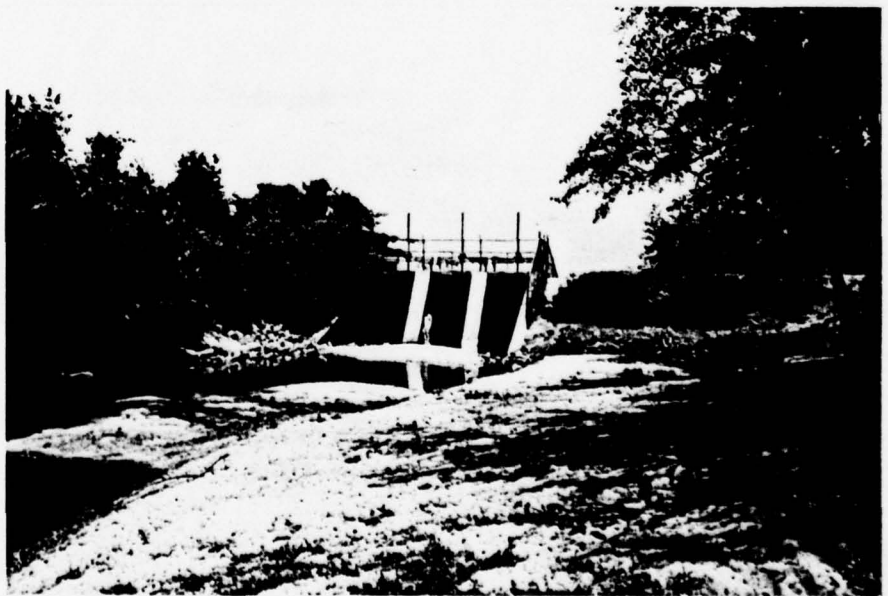
Sluiceways as viewed from Raceway
June 1978

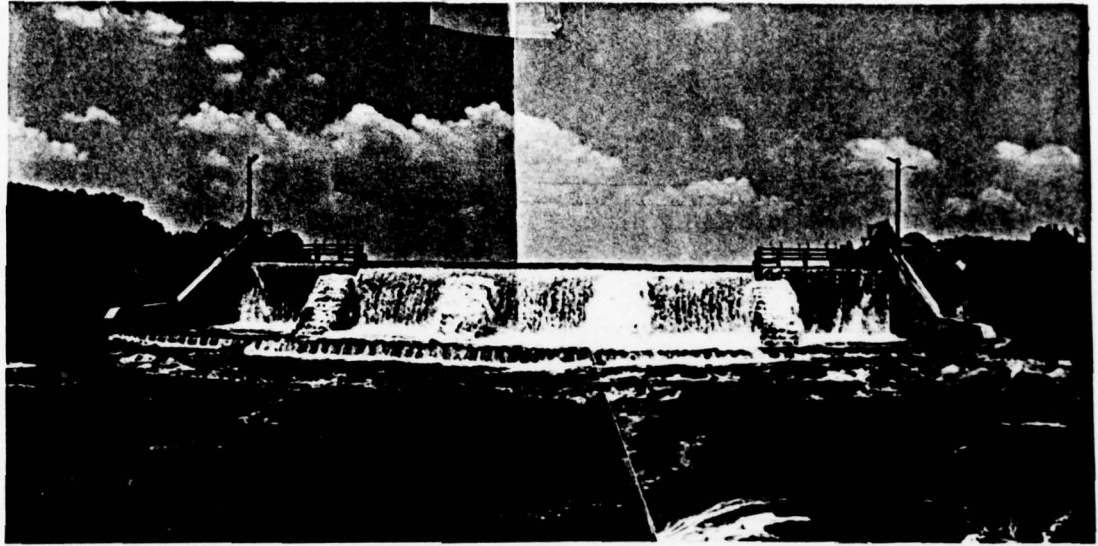
On inspection, the spillway appeared to be in adequate condition, with the inflatable Fabridam functioning well. However, there are several deficiencies, the more noticeable being the inadequacy of the sluice gates to draw down the reservoir in the event of a weakness developing in the embankment, and the perched downstream spillway apron which would subject the channel to sweepout for releases in excess of about 600 cfs. Further, the capacity of the spillway, as presently constructed is deficient for handling floods of more than those of moderate frequency.

Spillway
June 1978

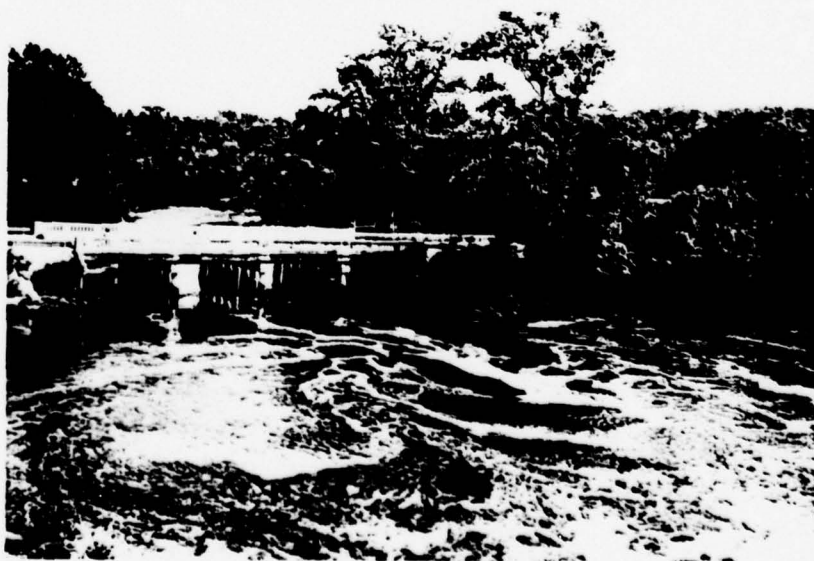
Further investigations should be undertaken in the near future as a collapse of this dam could conceivably wash out the hydraulically substandard (in relation to the SDF) Sharp Street bridge immediately downstream and would significantly increase the hazard to loss of life and damage to property.

County Bridge downstream of Spillway

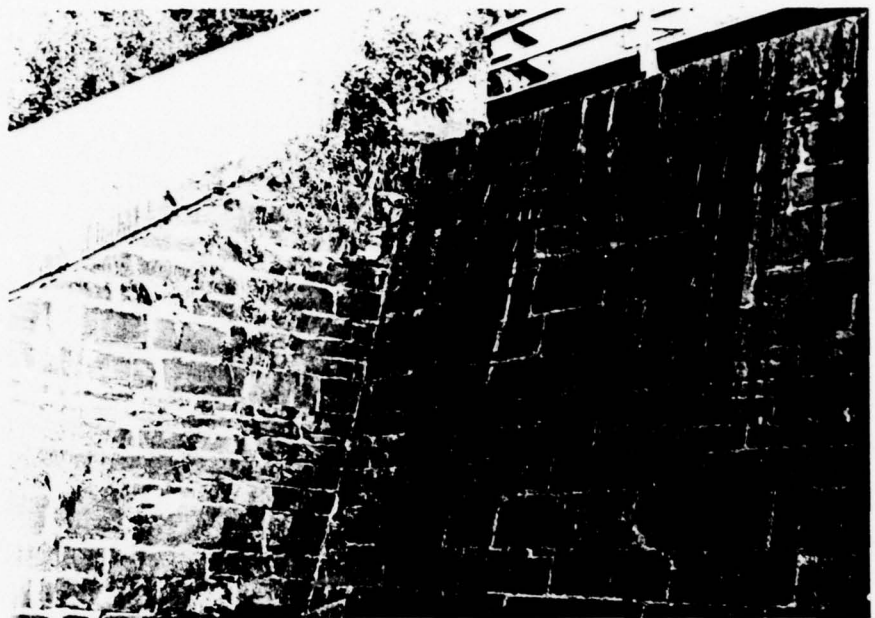
Spillway and Abutment faces
July 1978

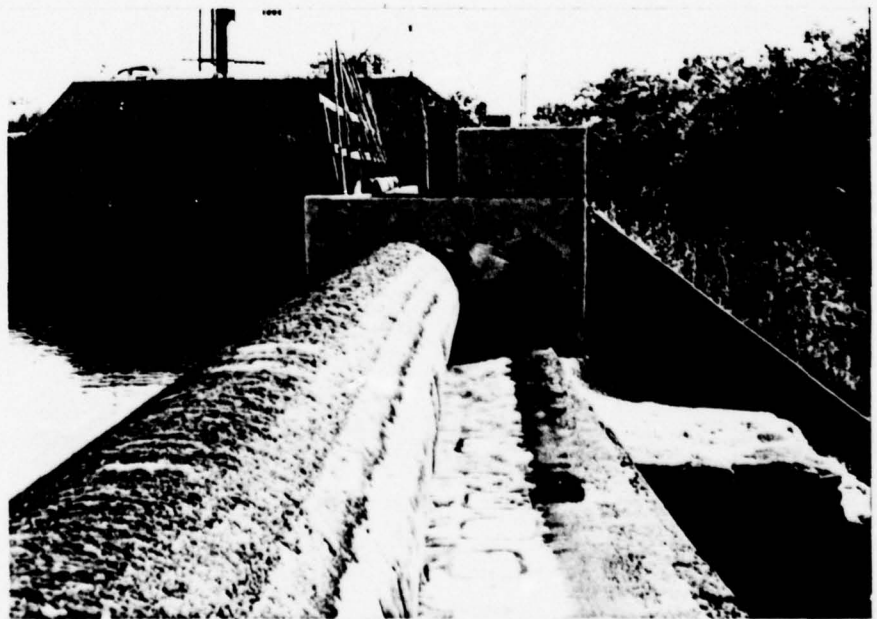
Inflated Fabridam
July 1978

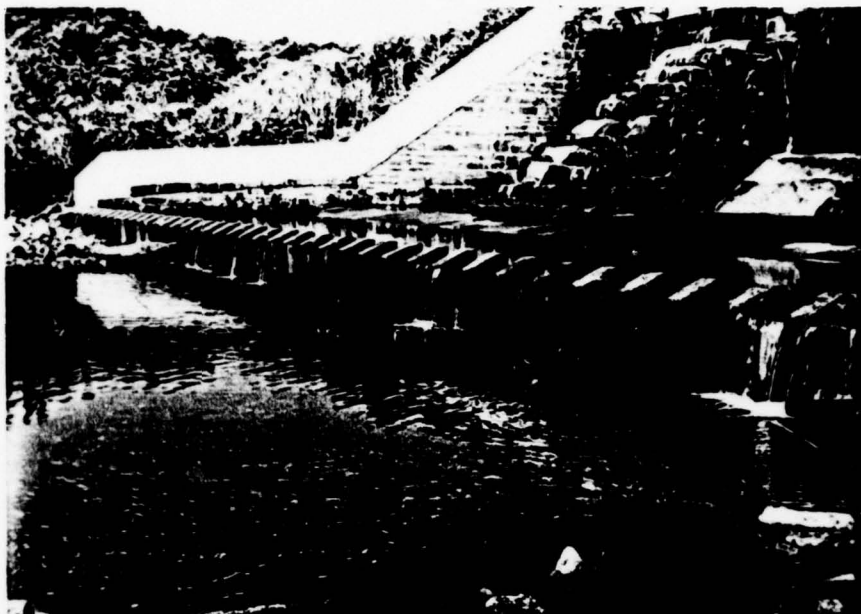
Sheet Piling at front edge of slab
July 1978
